# Manhole Inspection Summary

Manhole # S39S\_\_036MH

Insp Date: **3/13/08 11:13 AM**

**Location** Address: **1341 jackson**

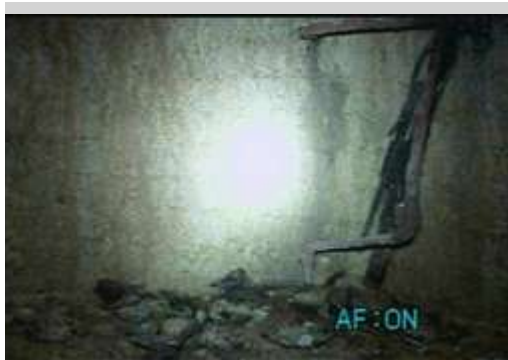
misc

bench debris

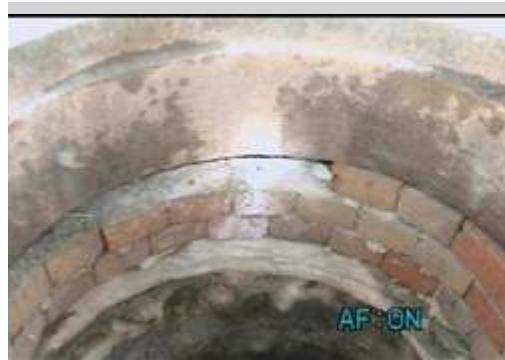
Defect 2

Condition: ☐ Sound ☒ **Cracked** ☐ Root Intrusion ☒ **Loose Brick** ☒ **Deteriorated**

chimney loose brick and deteriorated and  
from offset

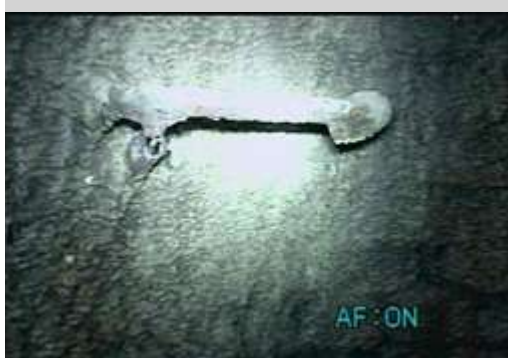
Count: **6** Missing: **0** ☒ **Corroded**

corroded step

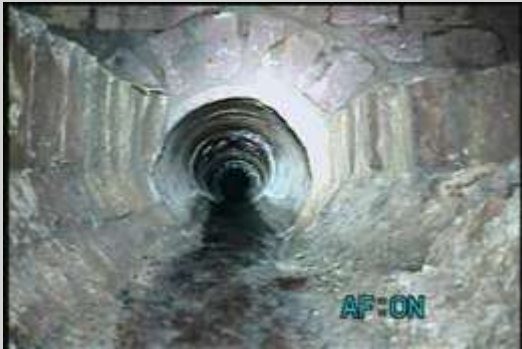
12 O'Clock Outflow

8 in. Circular Gravity Sewer  
Pipe Out @ 12 O'Clock

Invert Depth: **11.80** (ft.) Flow Characteristics: **Fast**

Infiltration: **None** Pipe Seal Cond: **Unknown**

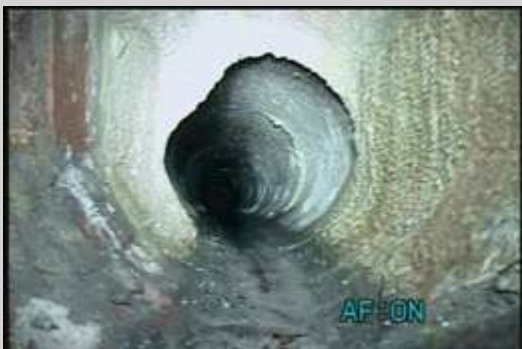
3 O'Clock Inflow

8 in. Circular Gravity Sewer  
Pipe In @ 3 O'Clock

Invert Depth: **11.50** (ft.) Flow Characteristics: **Slow**

Infiltration: **None** Pipe Seal Cond: **Unknown**

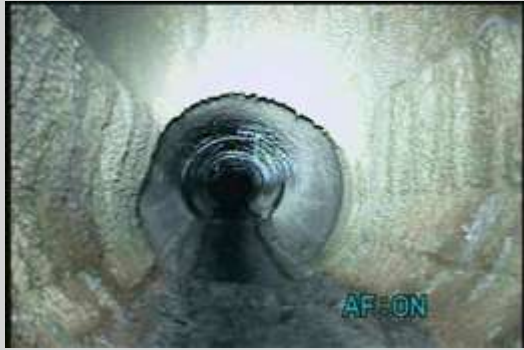
6 O'Clock Inflow

8 in. Circular Gravity Sewer

Pipe In @ 6 O'Clock

Invert Depth: **11.70** (ft.) Flow Characteristics: **Fast**

Infiltration: **None** Pipe Seal Cond: **Unknown**
